Technical Note N-1170

HIGH EXPLOSIVE FIELD TEST OF HARDENED ELECTRICAL GENERATORS

May 1971

NAVAL CIVIL ENGINEERING LABORATORY
Port Hueneme, California 93043

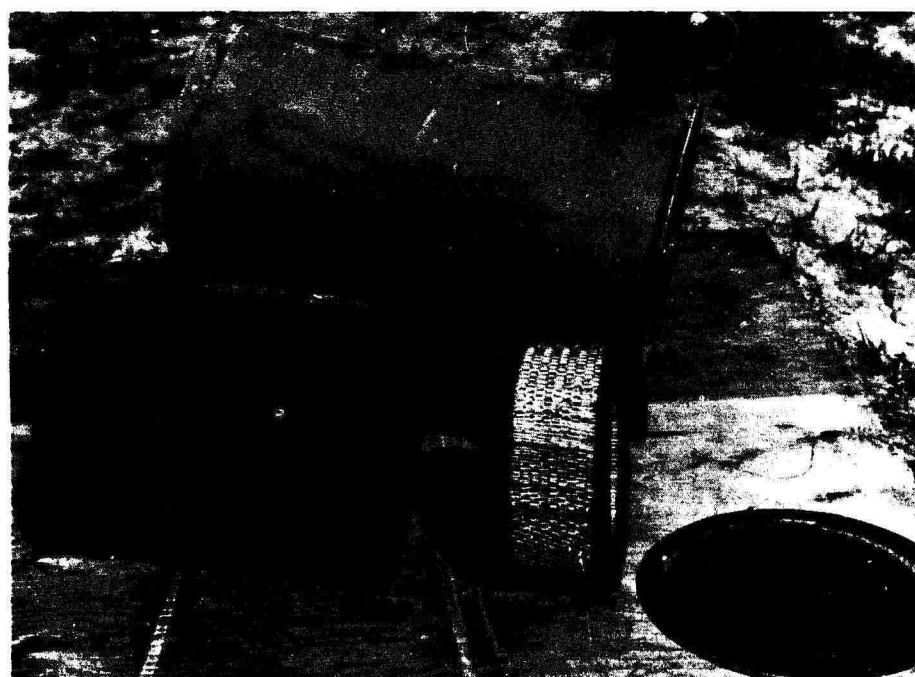
Figure 5. Disassembled hardened air cleaner.

(c) A conventional oil-bath type air cleaner is normally provided with the diesel engine but this type of air cleaner suffered extreme damage in the PRAIRIE FLAT test. A new blast-proof air cleaner was designed to protect the engines from excessive amounts of the dust and dirt encountered during the blast. A short section of 10" diameter steel pipe fitted with an automotive type paper air cleaner element, a plug of porous polyurethane foam, a foam support plate of perforated steel, and a thick flame-shield screen are shown disassembled in Figure 5. This air cleaner was bolted on top of the generator frame and connected to the engine intake manifold through flexible connections.

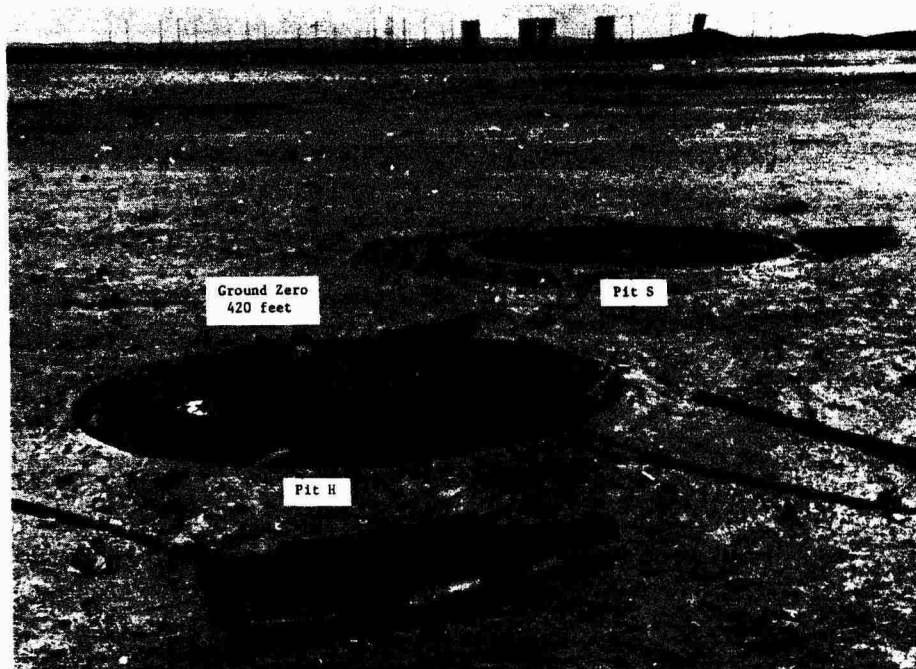
Figure 7. Pits after test.

Fifteen minutes after the detonation, NCEL personnel entered the blast area and found both generator sets running. As shown in Figure 7, the two-layer grate covers both suffered damage; however, only that of Pit "H" in which the top layer of parallel bars was perpendicular to the direction of blast wave travel was damage serious. Damage to the electrical fuse disconnect box had dislodged one end of a fuse from its clip in Pit "S" disrupting electrical output in one of the three phases, but otherwise the units were operating normally. The extent of this damage can be clearly seen in Figure 8. The concrete girdle to which the grates' periphery was attached was severely cracked. The soil around Pit "H" which had been excavated and recompactd prior to the test suffered little depression due to air blast loading; however, the soil around Pit "S" was found to have been permanently depressed from 6 to 8 inches below the existing ground level. This depression was attributed to improper backfilling of the soil around the pit by the contractor.

Only a small amount of crater ejecta was found on the ground at the pit location, 420 feet from ground zero. Although several large lumps of hard clay were found on the grate covers, these missiles did not appear to have caused the damage observed. The $3/16"$ x $2"$ flat bars of which the grates were formed were bound with and welded to a $1/4"$ x $2"$ border strip. Welding of the grate bars to the border strip was of very poor quality. Inadequate weld penetration and poor fit both contributed to failure of these welds. Under the high loading imposed by the air blast these welds were broken; about $1/3$ of the bars on Pit "H" were found to have been torn loose. The grate cover on Pit "S" in which the top layer of bars was parallel to the direction of blast wave travel suffered only minor permanent bending.

2. Damage to the pit structures consisted of minor fractures in the concrete girdle at the top of the pits and of moderately severe damage to the top grate layer of Pit "H".

Evaluation of the effectiveness of the two-layer grate design is difficult because the items damaged in PRAIRIE FLAT test had been hardened for this test. The principal information gained in this test was that high quality construction must be employed to prevent damage.

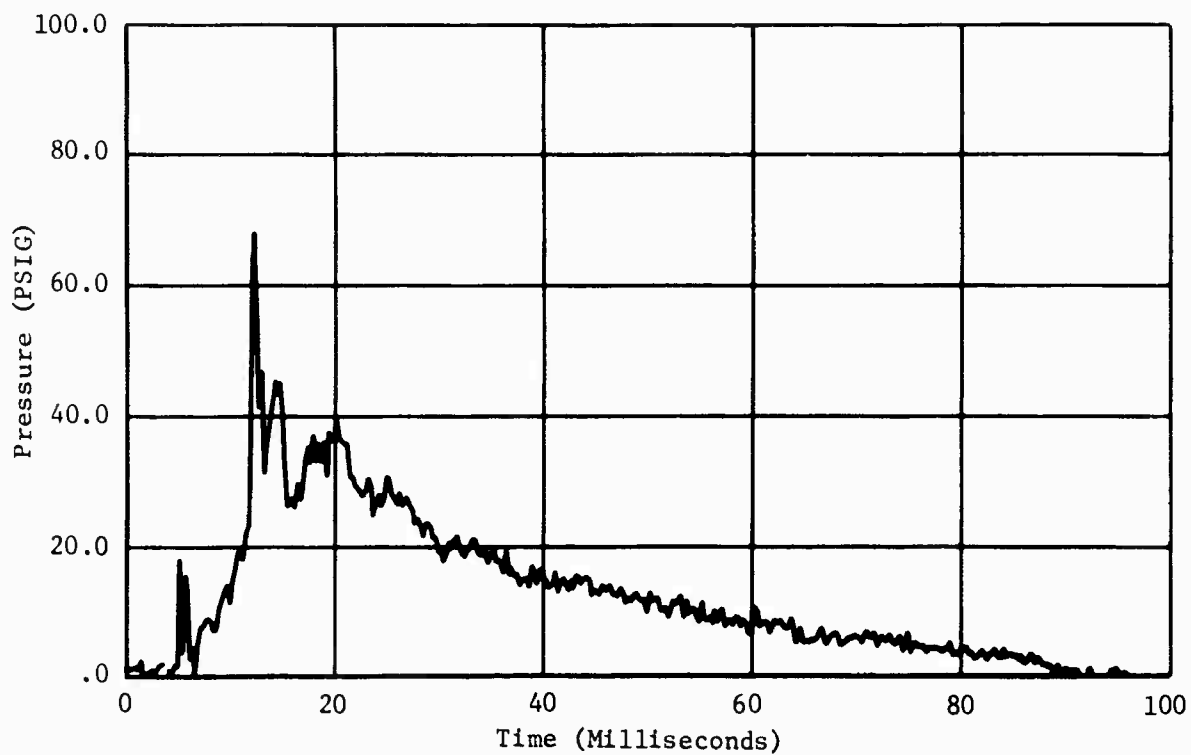
Figure 9. Overpressure time history in Pit H.

The overpressure within Pit "H", shown in Figure 9, indicated that only limited penetration of the initial shock wave occurred. An initial shock wave of only 22.4 psig was followed by a relatively slow increase to a peak pressure of 68.5 psi in 9 milliseconds. The pressure then decayed slowly to atmospheric pressure in 108 milliseconds. Similarly, in Pit "S", the initial penetrating shock wave was 23.5 psig with a rapid rise to 30.3 psig in 0.2 milliseconds. A subsequent slow increase to a peak pressure of 59.9 psig occurred over the next 10.6 milliseconds. Pressure decay of this peak level to atmospheric then occurred over an 88 millisecond period for a positive phase duration of 99 milliseconds.

The blast wave arrival time of 69.5 milliseconds was almost exactly as predicted and was 3.5 milliseconds less than that in PRAIRIE FLAT because of the shorter distance of ground zero. The maximum pressure recorded in Pit "H" of 68.5 psig was somewhat higher than that for the PRAIRIE FLAT test, but was possibly caused by the failure of the top grate layer. In Pit "S" the peak pressure of 59.9 psig was about the same as the pressure in a similarly oriented pit tested in PRAIRIE FLAT.

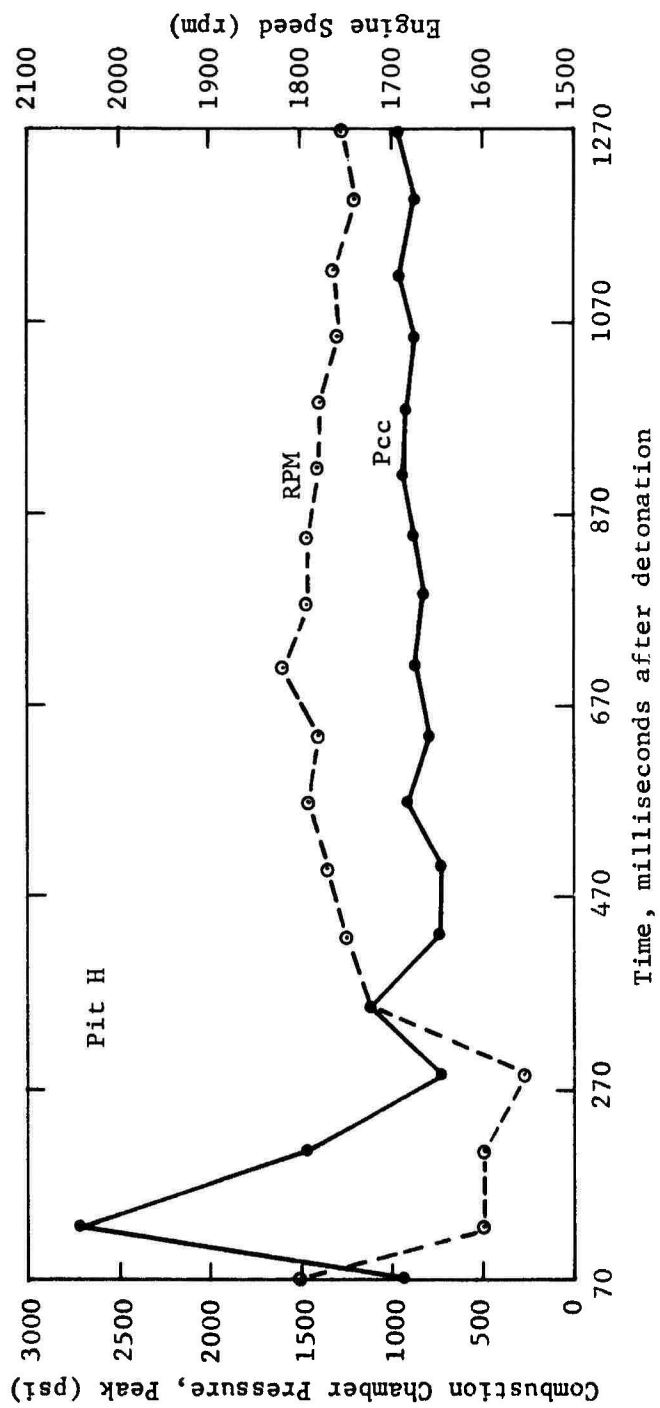
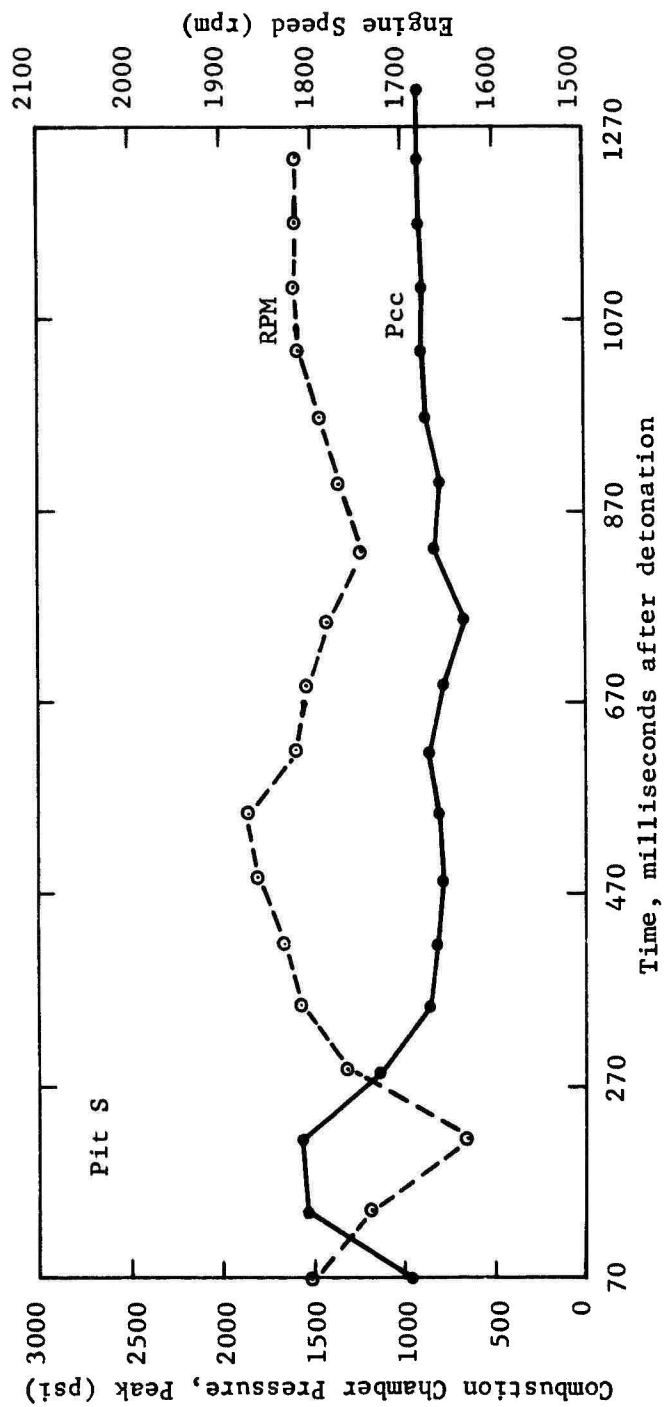
Measured peak combustion chamber pressure and engine speed time histories for both pits are shown in Figures 10 and 11. In Pit "H" the peak combustion chamber pressure was about 2700 psig, more than 2.85 times the normal 950 psig. Following the initial peak, combustion chamber peak pressure decayed rapidly to nearly 84% of normal at 640 milliseconds and then returned to normal at about 910 milliseconds. The engine speed decreased from 1800 rpm to about 1550 rpm in the period from 70 milliseconds to 214 milliseconds. Subsequently, engine speed returned rather slowly to 1800 rpm at 670 milliseconds after detonation. The resultant generator output frequency decreased from 60 cycles per second to 51.8 cycles per second, about 13.7% below normal. In Pit "S" the peak combustion chamber pressure was about 1550 psi, nearly 1.62 times the normal 960 psig. After the initial peak pressure occurred, the subsequent pressures decayed to about 69% of the normal at 760 milliseconds.

After an initial sharp decrease from 1800 rpm to 1630 rpm at 214 milliseconds after detonation, engine speed rose to nearly 4% above normal at 552 milliseconds. Subsequent engine speed varied about the normal 1800 rpm with decaying oscillation of less than 1.5% of the normal speed.

The maximum combustion chamber pressures were slightly more than one-half in Pit "H" and one-third in Pit "S" of the 4400 psig measured in laboratory overpressure tests. The short duration of the DIAL PACK overpressure pulse and the blast protection afforded by the hardened air cleaner, muffler and air cleaner are thought to have caused the reduction in combustion chamber pressures.

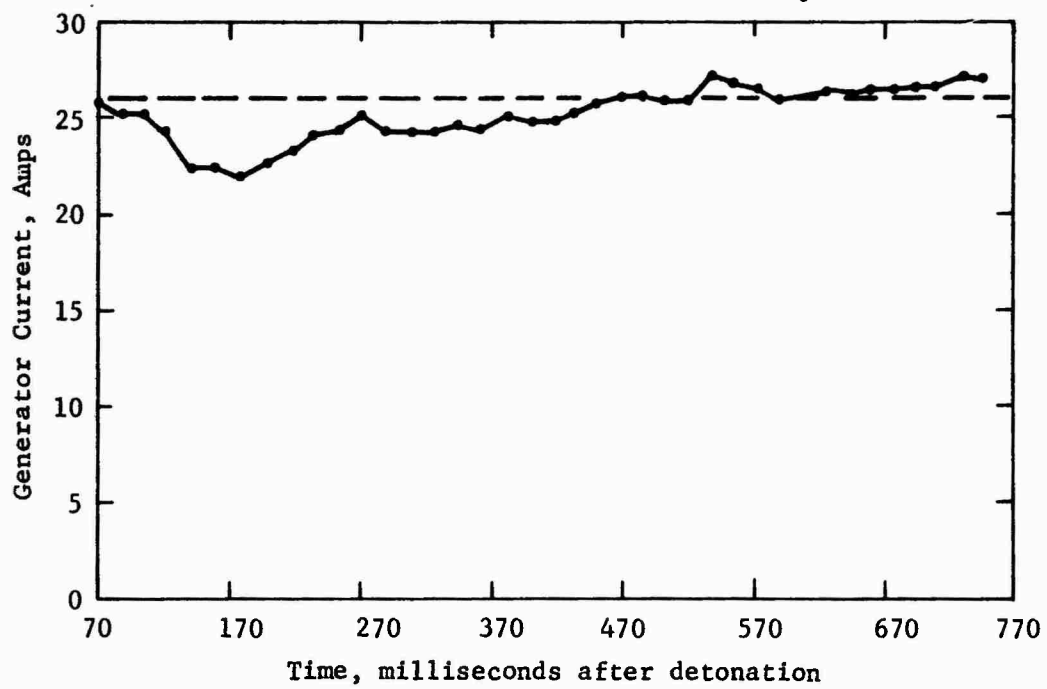
Figure 12. Generator output current in Pit H.

In Pit "H" the generator electrical output current decreased to 84.6% of normal at 180 milliseconds after detonation and returned to normal at 450 milliseconds, as shown in Figure 12. In Pit "S" the generator electrical output current in one phase was found to have stopped at 83.7 milliseconds, as soon as the blast wave had penetrated the pit and dislodged one of the three fuses employed.

Changes in the frequency and current from the generator were greater than would be permitted under the definition of precise power, but would not present serious problems for electrical equipment such as lights, heaters, and pumps used in hardened sites. Loss of a fuse in Pit "S" caused a loss of data for that generator when that phase of the three phase output was interrupted. Redesign of the fused disconnect is recommended to prevent such occurrences.
